Monitoring Data Record

Project Title: R-2552B Clayton Bypass COE Action ID: 200220745
Stream Name: Site 5 DWQ Number: 041760
City, County and other Location Information: US 70 Clayton Bypass from I-40 to US 70
Station 82+60 to 85+50 -L-
Date Construction Completed: 4/21/06
Monitoring Year: (1) of 5
Ecoregion: _____ 8 digit HUC unit 03020201
USGS Quad Name and Coordinates: _____

R-2552B Clayton Bypass

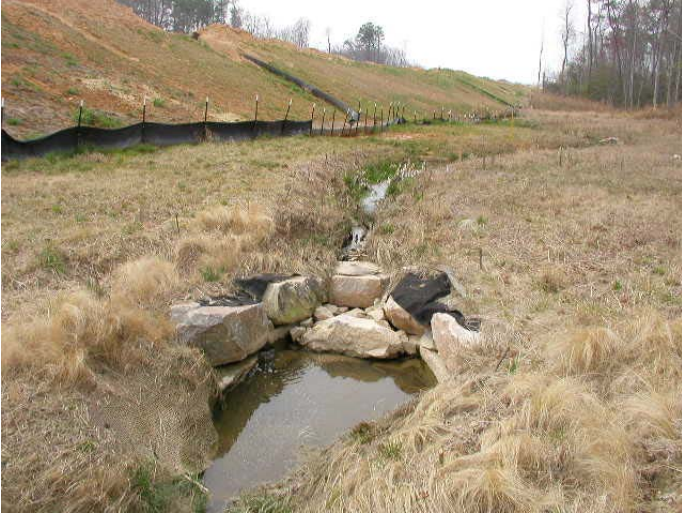
Photo Point #4 (Upstream)

The stream relocation is stabilized except for the second cross vane upstream (Photo Point #4 Upstream) from the box culvert. This cross vane has water piping through the structure which has develop a slight headcut. Remedial action may be needed is this area. NCDOT will continue to monitor this stream relocation.

3/14/07	Station 83+80-L- LT.	Station Number	Station Number	Station Number	Station Number
Structure Type	Cross vane				
Is water piping through or around structure?	Water is piping through the cross vane				
Head cut or down cut present?	Slight headcut				
Bank or scour erosion present?					
Other problems noted?
